Project 1.1: Improved Intersection Stormwater Management Dataset

Intersection: Norchester Ave. & Victoria Ave., Chesterfield Heights, Norfolk, VA

NORCHESTER AVE. AND VICTORIA AVE. EXISTING CONDITIONS EXHIBIT

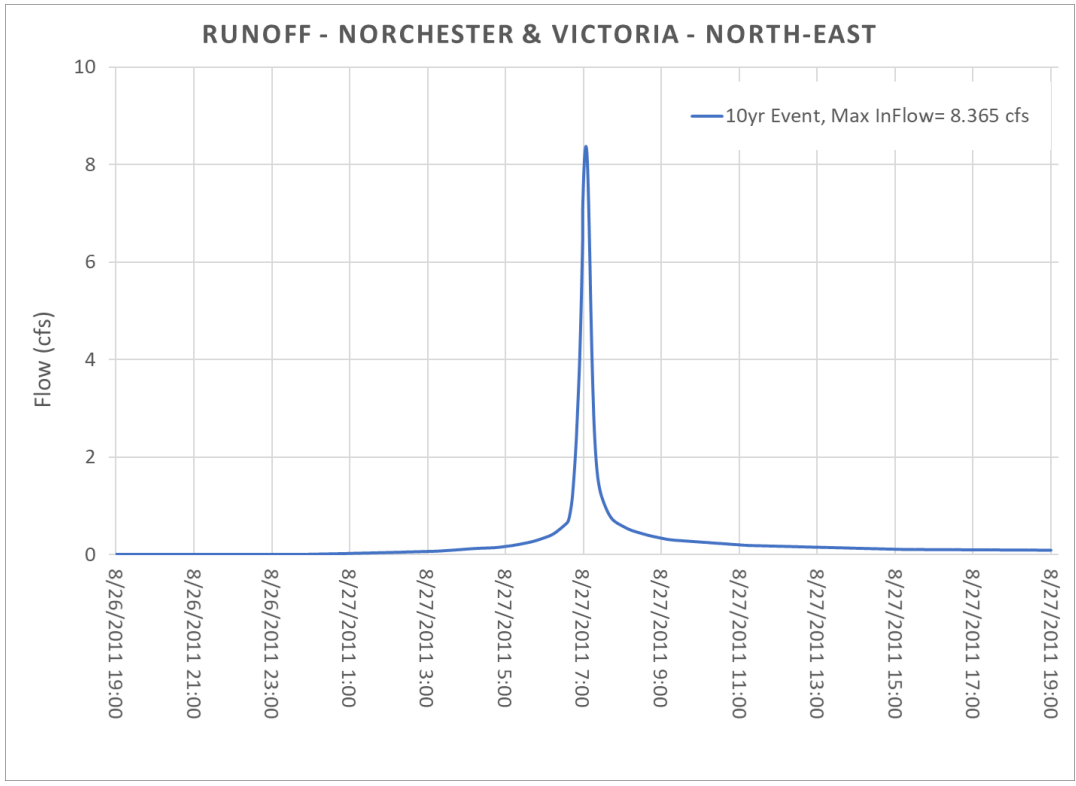
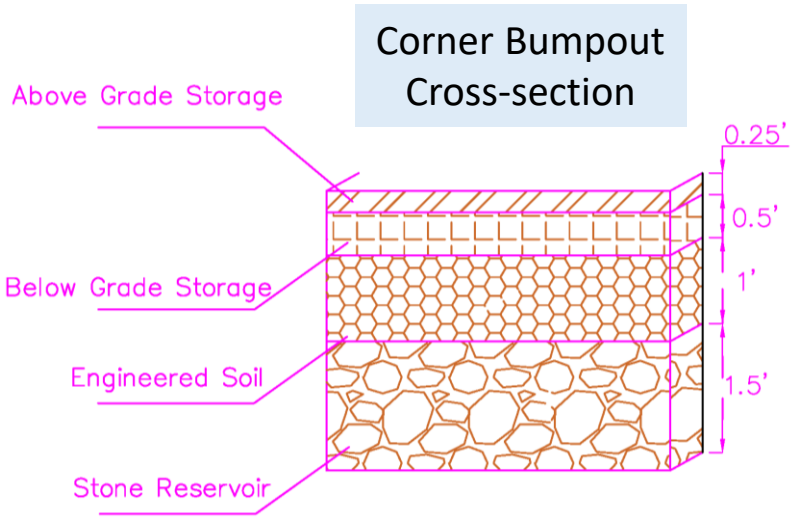
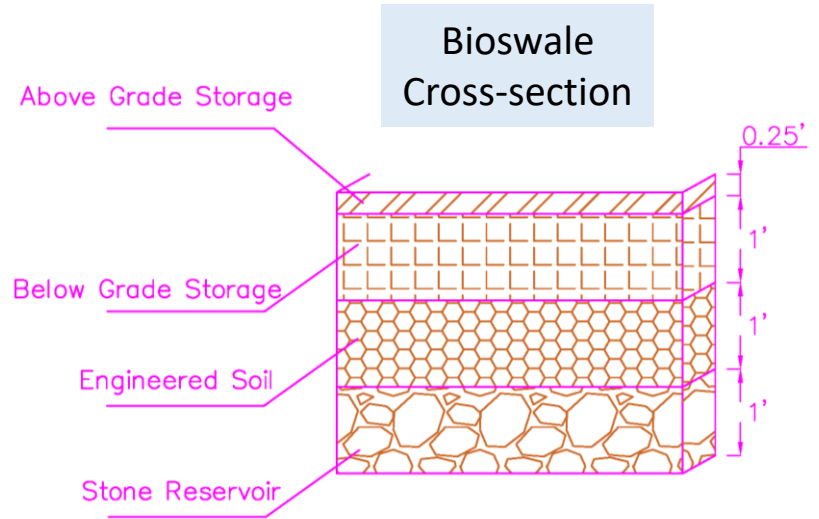
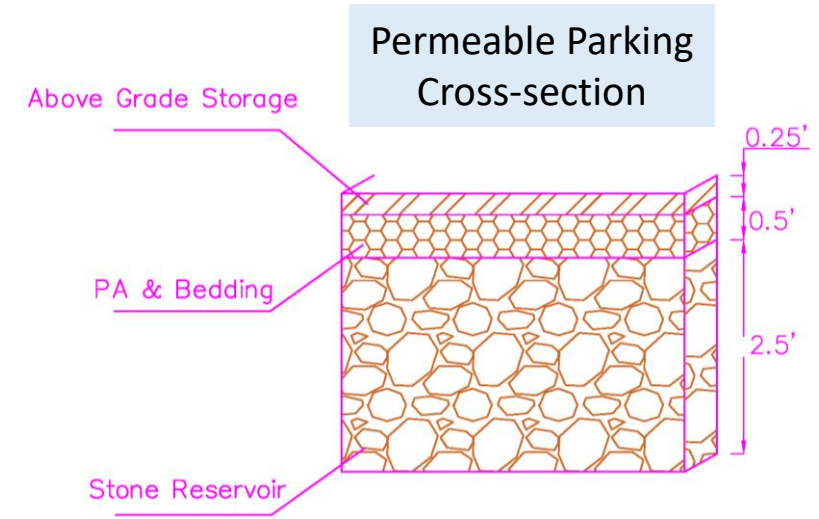
| Norchester-Victoria (North-East) | |

1. Drainage Areas (SF), Storage Volume (cf), and Hydrograph for 24-hr 10 yr storm event are shown below broken out by each corner of the intersection.
2. Included below is a figure with existing topographic survey and utilities.

| Norchester-Victoria (North-East) | |
|---|---|
| Drainage Area (sf) | 68868 |
| Impervious | 53% |
| Pervious Area Curve Number | 76 |
| Green Infrastructure Type | Total Storage (cf) |
| Corner Bumpout | 234 |
| Bioswale | 1804 |
| Permeable Parking | 1698 |
| Total | 3736 |

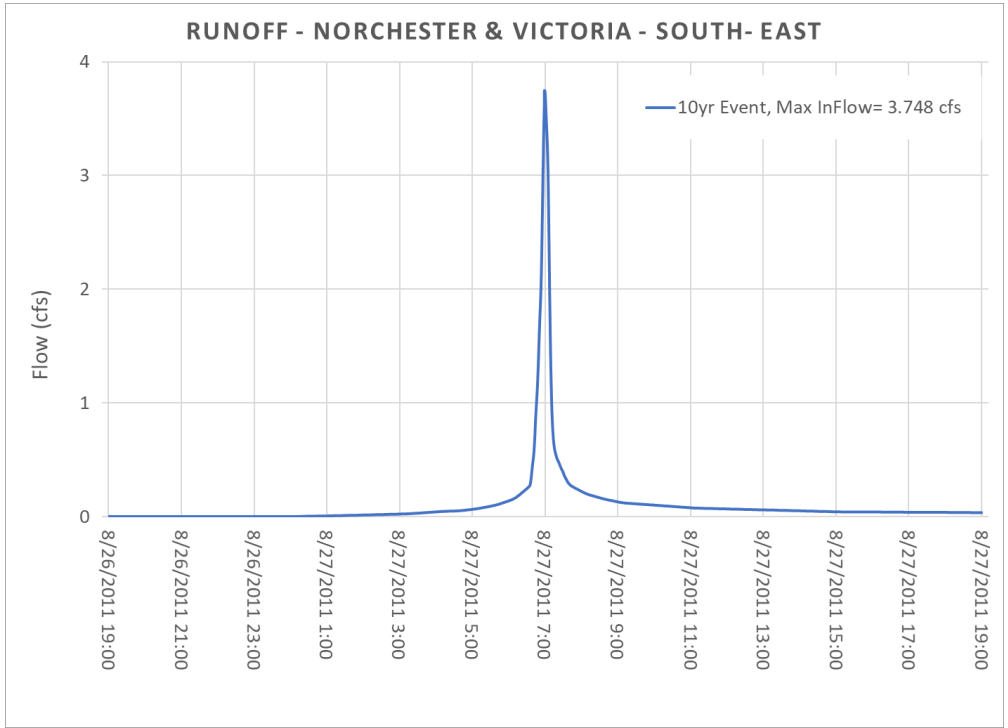
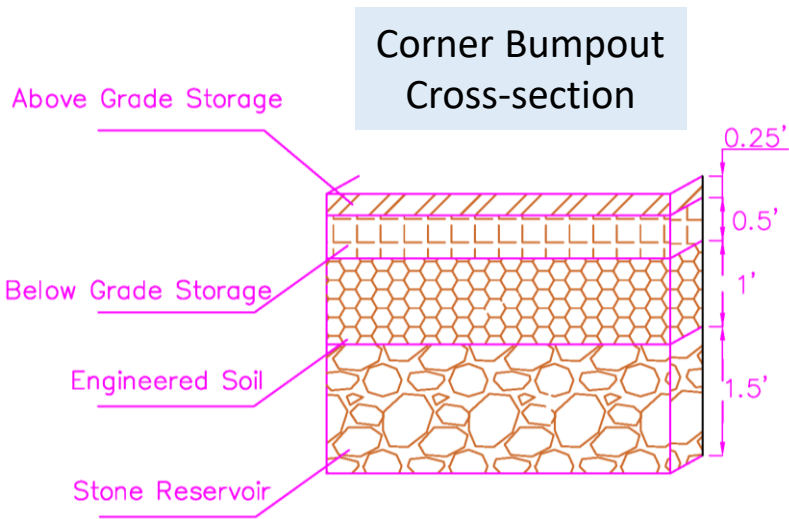
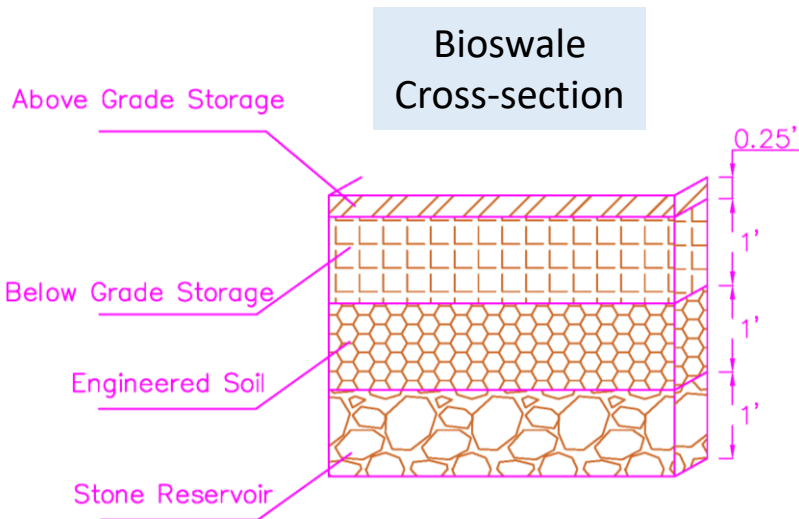
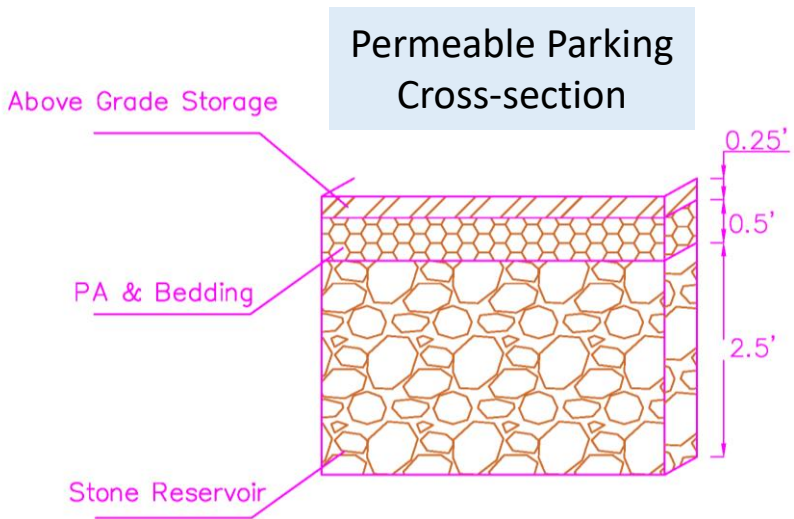
| Norchester-Victoria (South-East) | |

| Norchester-Victoria (South-East) | |
|---|---|
| Drainage Area (sf) | 28009 |
| Impervious | 50% |
| Pervious Area Curve Number | 75 |
| Green Infrastructure Type | Total Storage (cf) |
| Corner Bumpout | 95 |
| Bioswale | 734 |
| Permeable Parking | 691 |
| Total | 1520 |

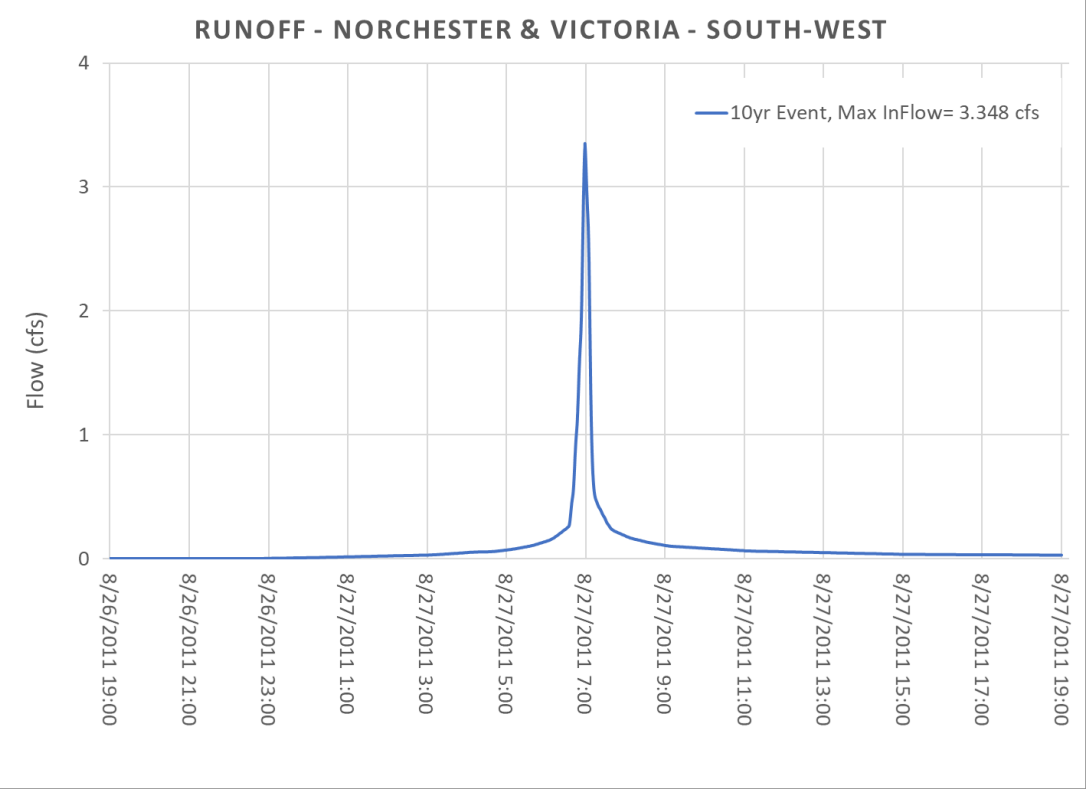
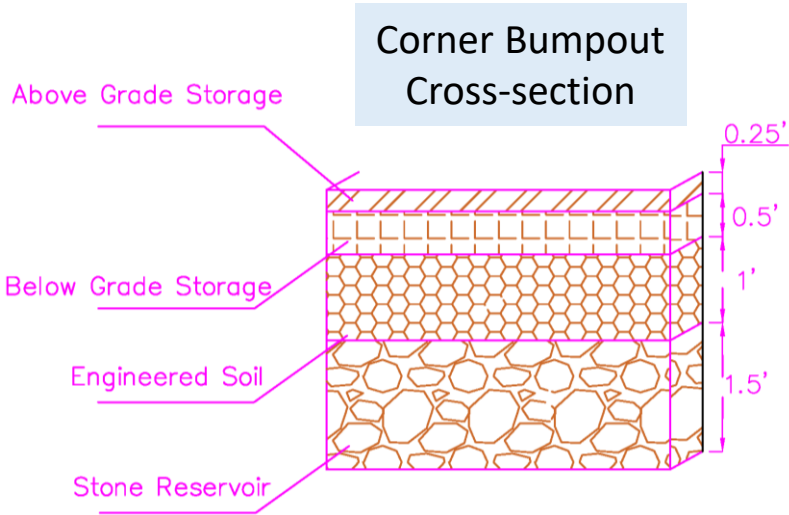
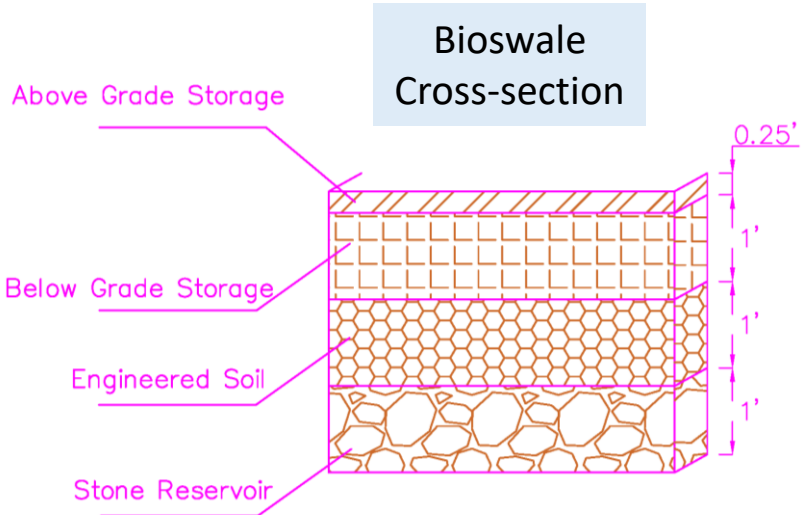
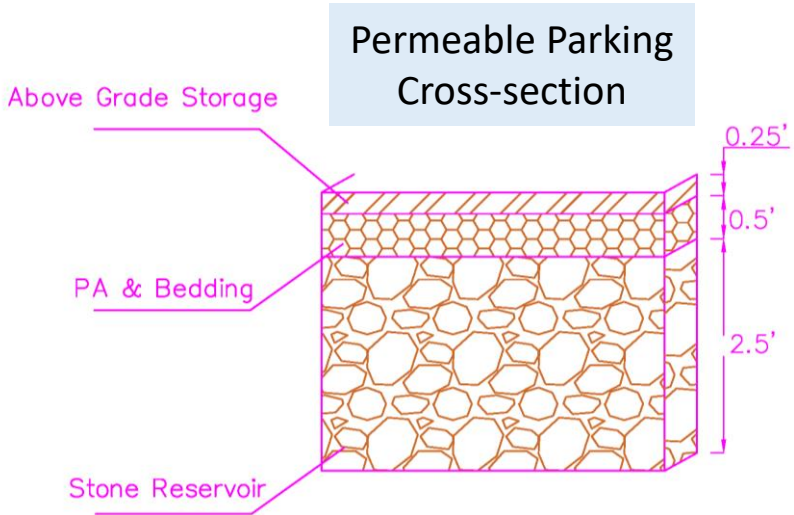
| Norchester-Victoria (South-West) | |

| Norchester-Victoria (South-West) | |
|---|---|
| Drainage Area (sf) | 22390 |
| Impervious | 65% |
| Pervious Area Curve Number | 77 |

| Green Infrastructure Type | Total Storage (cf) |
| Corner Bumpout | 76 |
| Bioswale | 587 |
| Permeable Parking | 552 |
| Total | 1215 |
